## Block 9, Alameda-3: Appraisal Update (Alameda reservoir)

Melbana Energy Limited (ASX: MAY) (**Melbana** or **Company**), a 30% interest holder in and Operator of Block 9 PSC onshore Cuba, is pleased to provide this operational update for the Alameda-3 appraisal well.

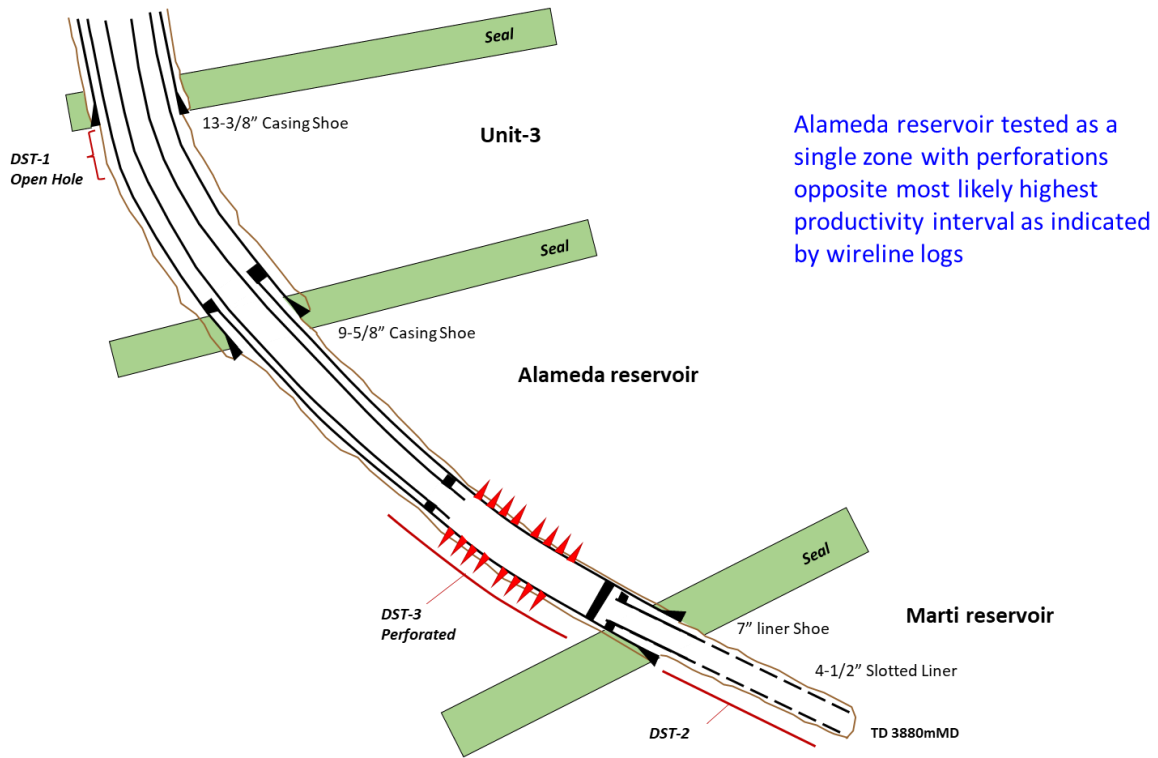
Alameda reservoir tested as a single zone with perforations opposite most likely highest productivity interval as indicated by wireline logs

Figure 1: Positioning of the Alameda reservoir where flow testing was undertaken at depth

Flow testing of the Alameda reservoir commenced on Monday morning, Cuba time, with the successful perforation of the casing between 3272 and 3450mMD (see Figure 1).

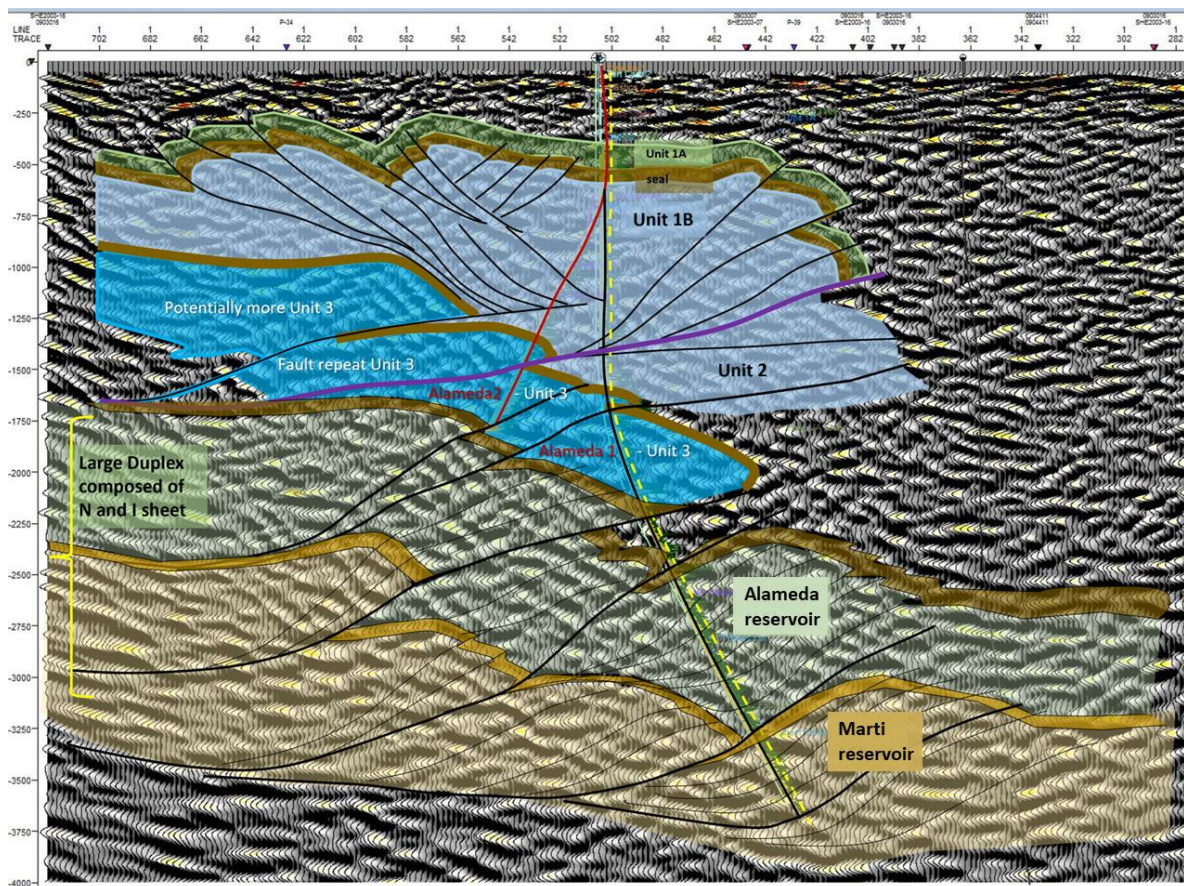
Figure 2: Depth of the Alameda reservoir relative to the Marti reservoir

The objective of the testing was to determine oil quality and flow rates for the Alameda reservoir (located above the recently tested Marti reservoir, which is separated by effective seal rocks (see Figure 2) to gain a broader understanding of that reservoir's production characteristics.

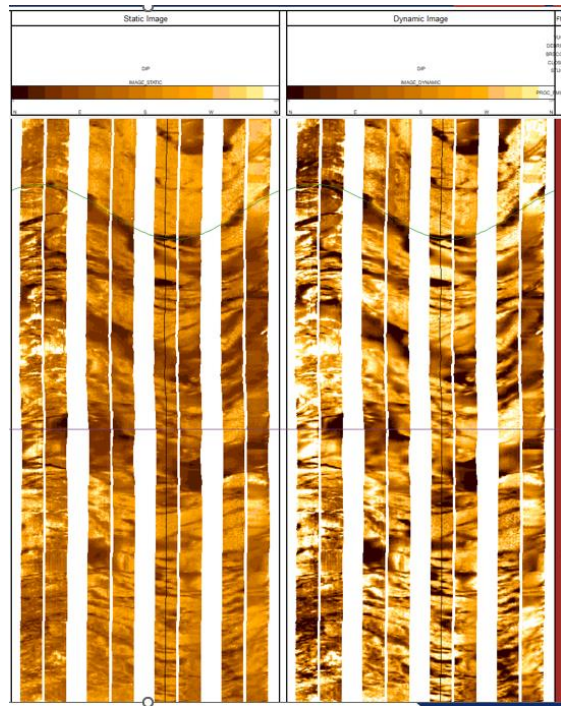
Figure 3 FMI image over Alameda reservoir showing potential good quality pay

The reservoir was tested as a single zone in the lower section interpreted to contain the highest porosity and productivity interval, as indicated by conventional log analysis and FMI (see Figure 3).

The inability of the well to flow does not fit with previous observations and expectations, given wireline and FMI over this interval indicate substantial good quality conventional (i.e. not fracture dependent) pay in addition to the highly fractured pay (see Figure 3).
